Occurrence Investigation Report

Runway Excursion

Boeing 737-400 JY-JAP

Tombouctou Airport, Tombouctou, Mali

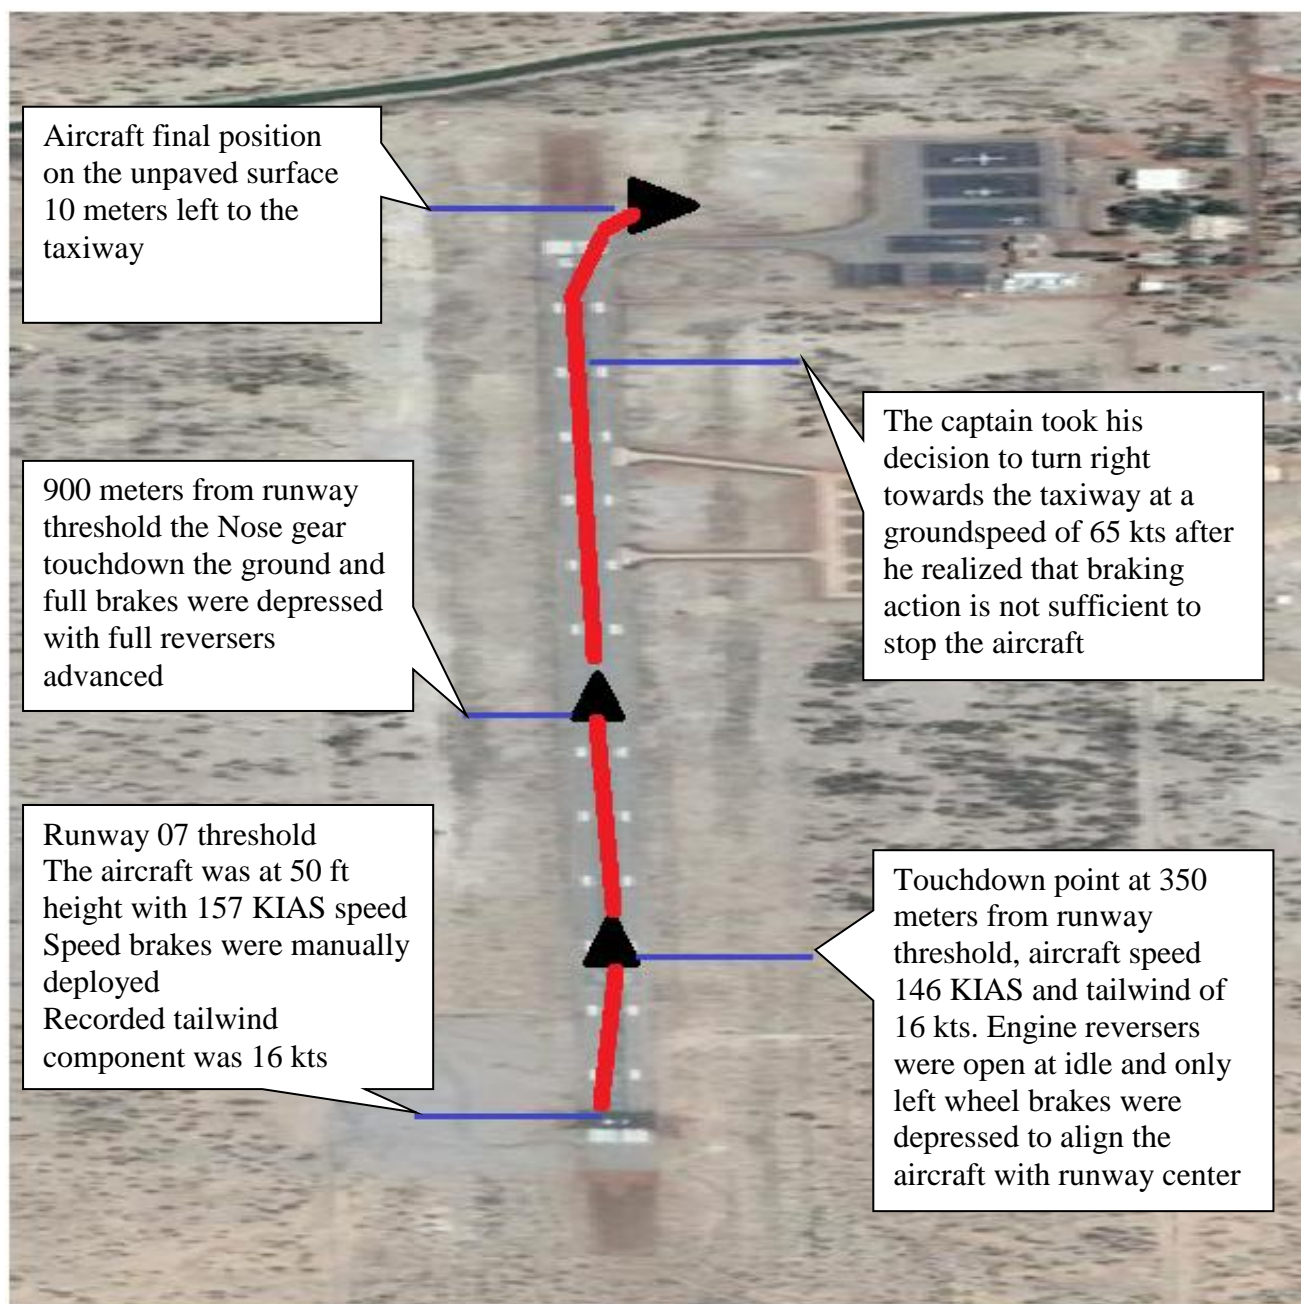
Figure 1

The aircraft landed at TOM on runway 07 at 08:35:53 UTC, just beyond the markings of the touchdown zone, approximately 350 m after the runway threshold with a speed of 150 KIAS, flaps 30, landing weight of 55,000 Kg and manually controlled thrust. The speed brakes were set manually to UP position just at touchdown. At touch down the speed reduced to 146 KIAS and engine thrust reversers were deployed manually with the left engine thrust reverser lagging in response with 3 seconds from the right engine resulting in a small drift to the right at 2°. The wheel brakes were applied on the left side only for about 5 seconds in what is believed to be an action from the pilot flying to return the aircraft to the center of the runway. Control column was showing 2.5° pitch up angle which continued for 5 seconds after touchdown. Immediately after the nose wheel touched the ground, the captain applied increased brake pedal displacement and maximum reverse thrust as he considered the rate of deceleration was inadequate. The co-pilot shared the commander's perception but he did not firmly depress his own brake pedals. The aircraft continued to roll on runway 07 which is 2,170 m long to depart the runway from the taxiway edge located on the right side at the end of runway 25; the aircraft came to rest on the unpaved area southeast to the runway/taxiway intersection. As shown in figure 1.

Aircraft ground run

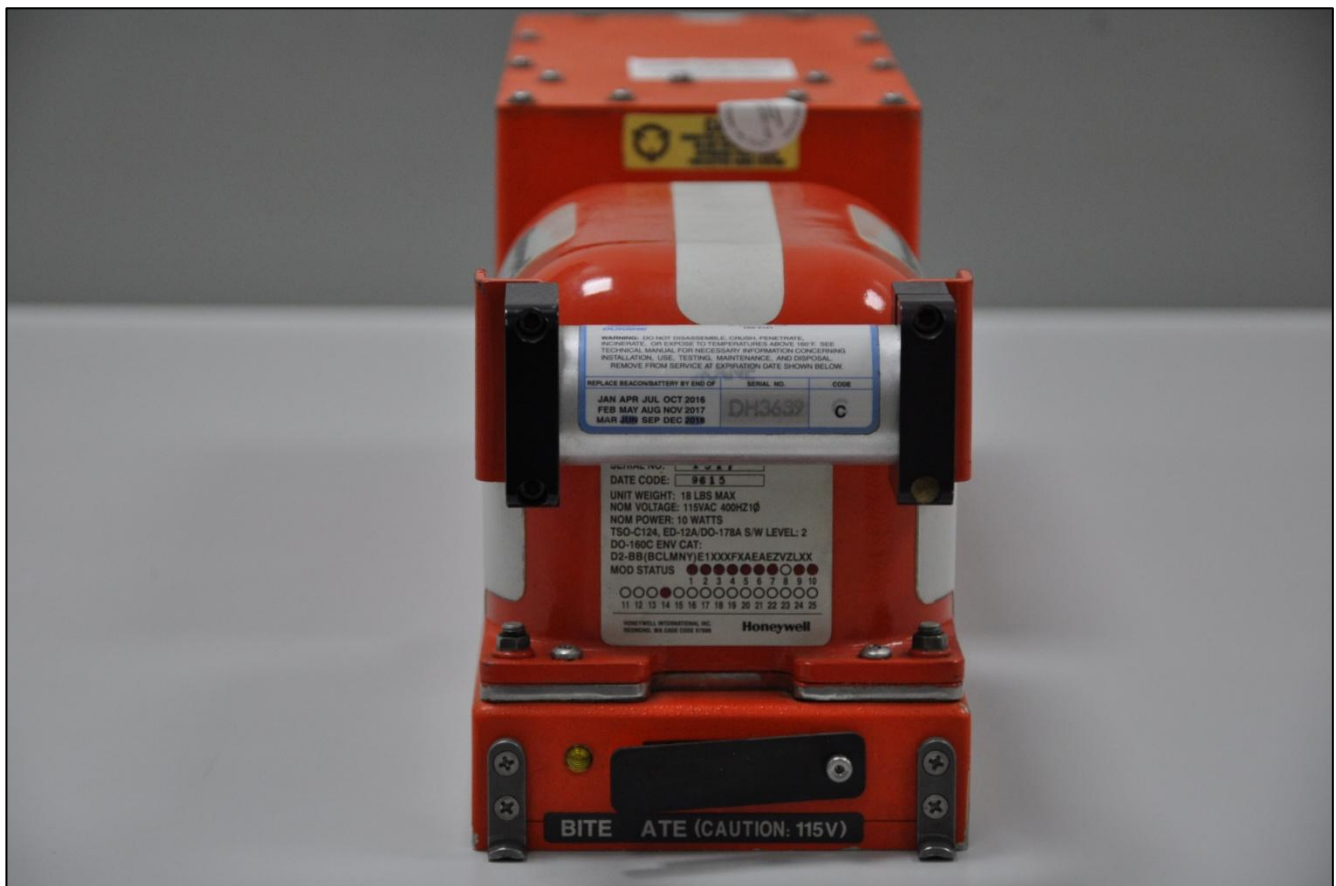
Figure 6

Manufacture:	Honeywell
Model:	SSFDR
P/N:	980-4700-033
S/N	1517
Medium:	Solid State
State of the recorder	No damage (visual inspection)
Recording Length:	Approximately 27 hours flight data
Recording quality:	Good

Flight Data Recorder – photo taken at GACA AIB Labs

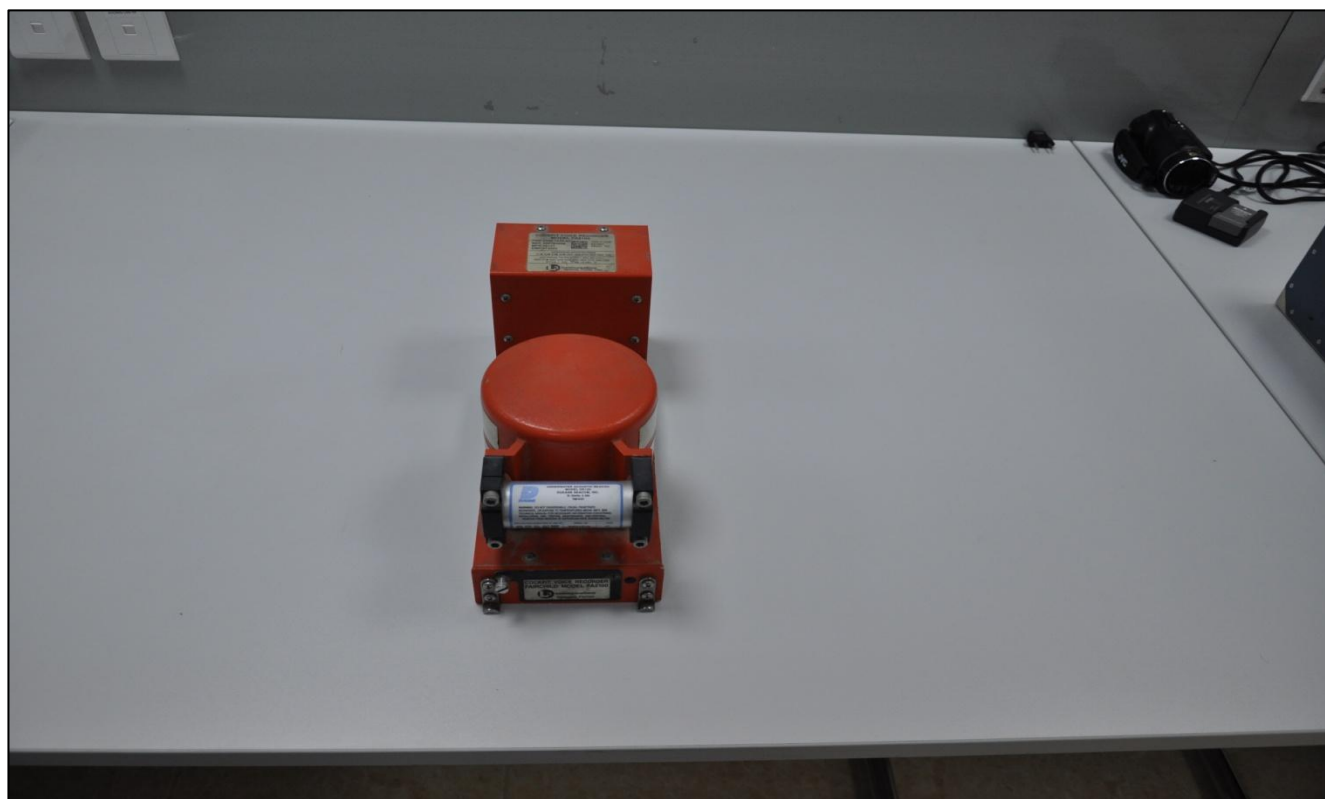
Figure 7

Manufacture:	L3
Model:	SSCVR
P/N:	2100-1020-02
S/N	000183859
Medium:	Solid State
State of the recorder	No damage (visual inspection)
Recording configuration:	2 hours, 4 channels
Recording quality:	Good and clear
Contents:	
2 hours	Channel 1: CM1
	Channel 2: CM2
	Channel 3: CM3
	Channel 4: AREA

Cockpit Voice Recorder – photo taken at GACA AIB Labs

No transcript is available so far for the investigation committee to make analysis on the human factors part, communication and other relevant matters that can be extracted from voice data recorded as the data was found erased. However; the investigation committee was able to identify some significant impairments that contributed to the incident through interview of the flight crew and collected statements from other parties.

- REC 4) It is recommended that Jordan Aviation stress on the importance of preserving flight data after occurrences and to set a procedure for consulting the management of the company whenever an occurrence take place to confirm the requirement for this data. This procedure is recommended to include administrative guidance to technical staff who may be requested to follow the data preservation and protection procedures to register their actions in the technical log and to sign against these actions.

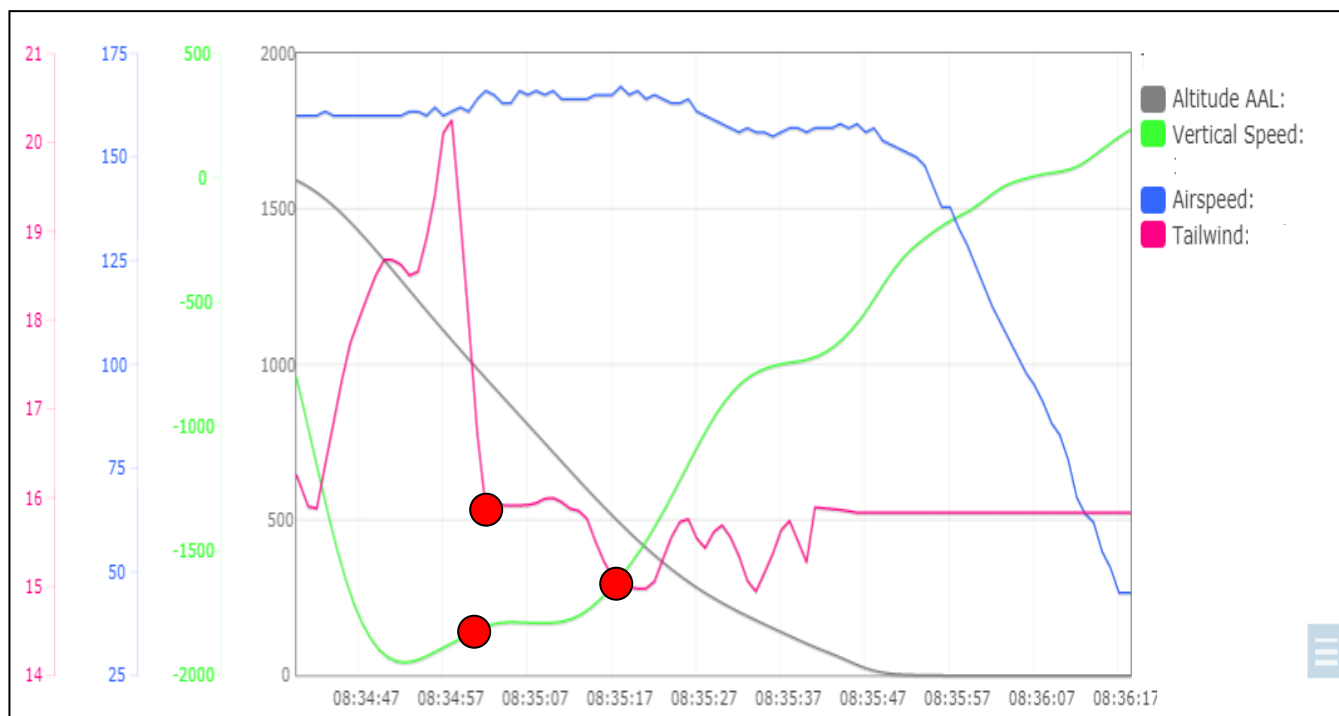
Figure 8

At 08:35:03 the aircraft was at 1010 ft AAL, with landing gears extended and flaps set at 30 deg, engine thrust was at flight idle and recording 35% N1. The vertical acceleration was still above the normal recommended limit as it was recording 1790 ft/min with tail wind component of 16 kts

At 08:35:40 the aircraft was at 104 ft AAL, the vertical speed was 727 ft/min and indicated airspeed maintained at 156 kts, with the wind still coming from the tail side with a magnitude of 16 kts. The engine thrust was increased to 72% N1 and the control column was pushed forward to reduce the pitch to 1.4 deg.

FDR Analysis – approach profile

- REC 3) It is recommended that Jordan Aviation's flight operations department stress the applicability of unstabilized approach policy, and in particular, the requirement to go around when the approach does not meet the stability criteria.

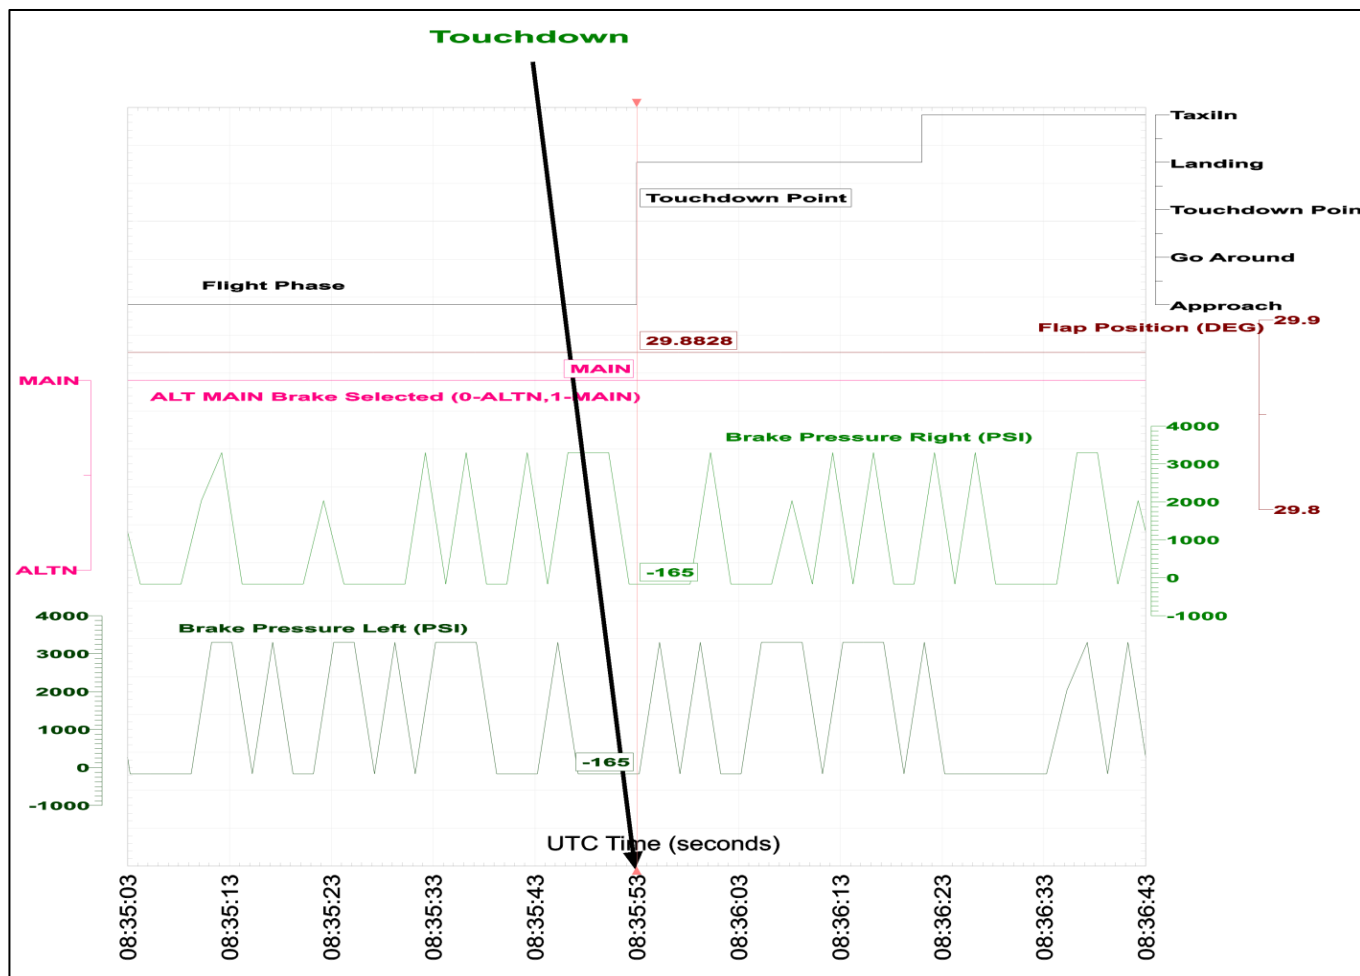
Figure 9

Use an appropriate autobrake setting or manually apply wheel brakes smoothly with steadily increasing pedal pressure as required for runway condition and runway length available. Maintain deceleration rate with constant or increasing brake pressure as required until stopped or desired taxi speed is reached. The crew did not follow the SOP during brake pedal depression.

If the pilot modulates the brake pedals, the antiskid system is forced to readjust the brake pressure to establish optimum braking. During this readjustment time, braking efficiency is lost.

FDR Analysis – Brake Application at Landing Roll

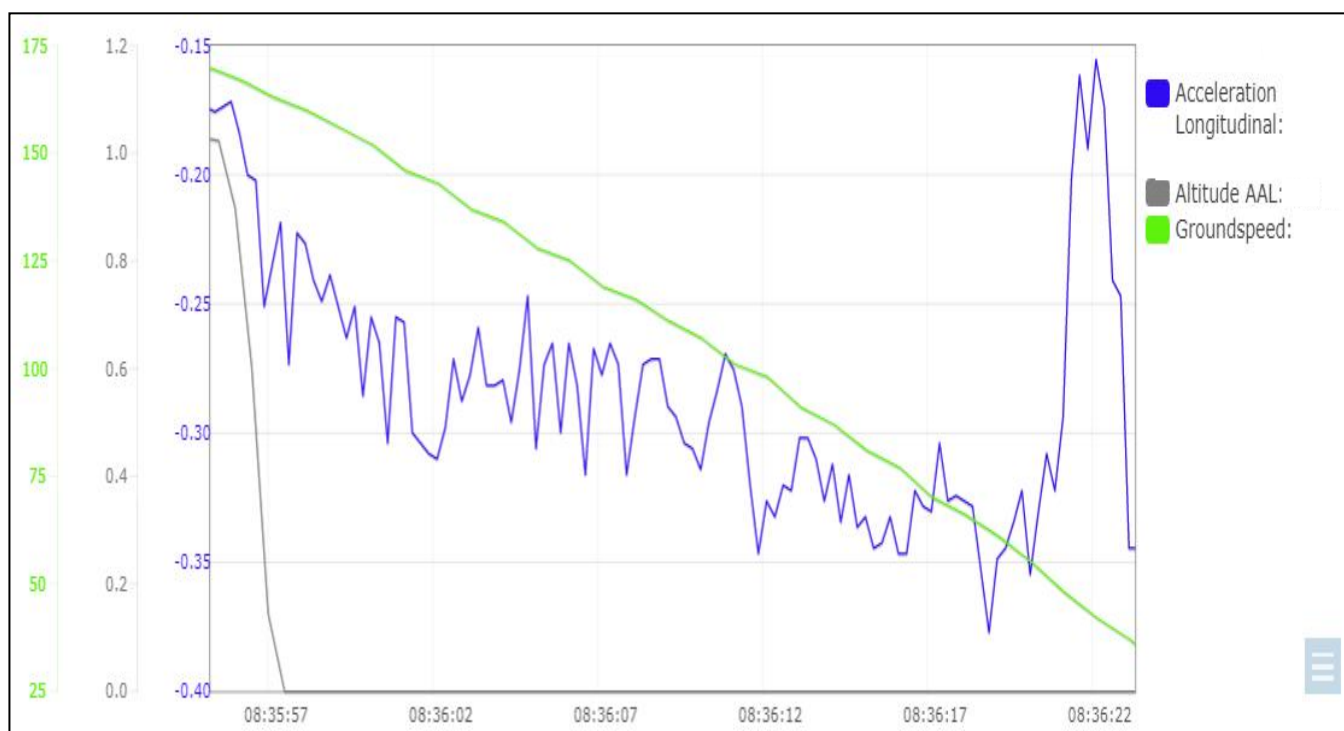
Figure 10

The aircraft started to deviate from runway heading towards the taxiway 25 seconds after the landing gear contact with the runway surface.

FDR Analysis – Deceleration during Landing

varied between low to medium. It then increased during the following seconds of the landing run reaching the highest value at the end of the run just before heading deviation.

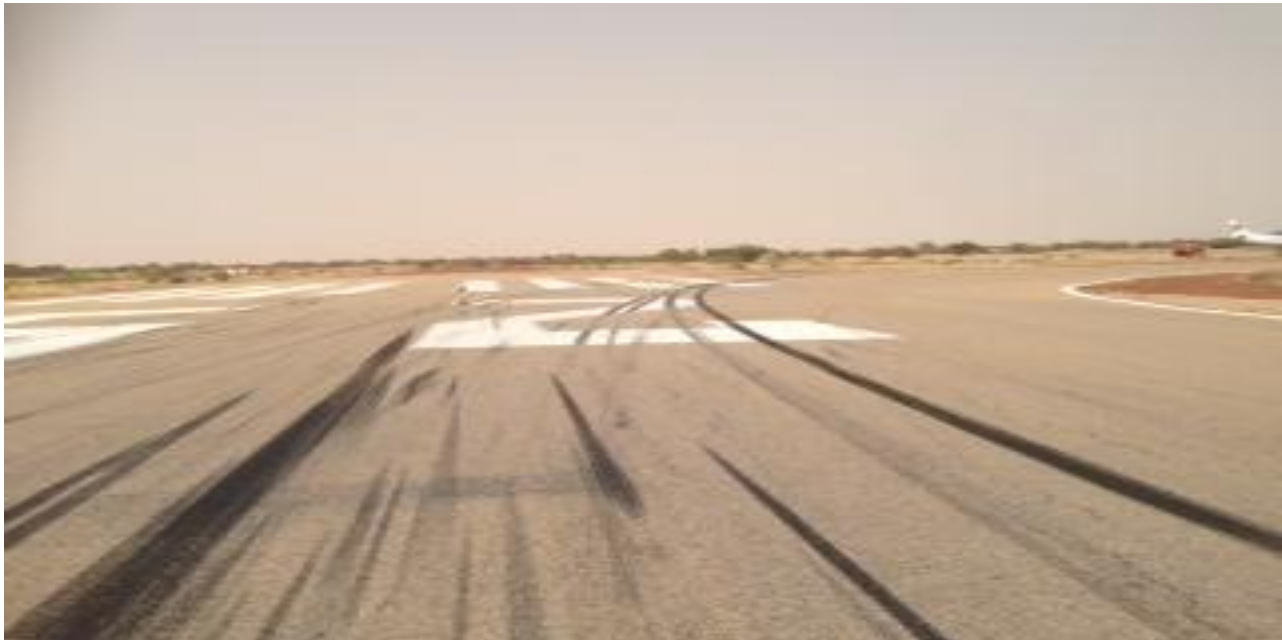
Figure 11

The high brake energy released from the braking action resulted in tires prints on the runway just prior to aircraft turn towards the taxiway track. This is clearly identified in figure 11

Tires Foot Print on the Runway Just before Turning towards the Taxiway Track
