Occurrence Investigation Report
Runway Excursion
Aircraft Overran the Runway during Landing
Solitaire Air
Boeing 737-300 JY-SOA
King Hussein Airport, Aqaba, Jordan
RYW 6888
AMM-AQJ
17September 2017

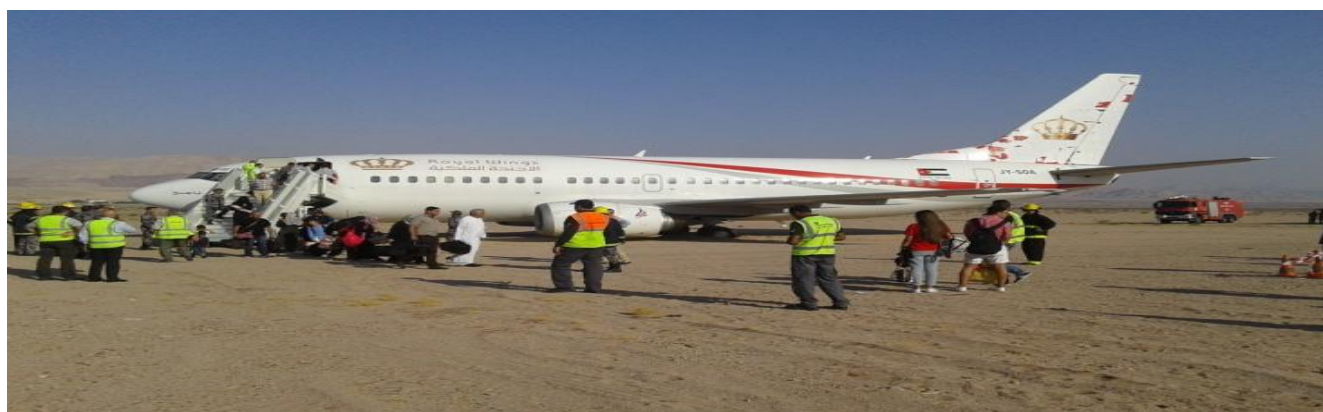
Figure 1.2

[Figure 1.2](#) below shows the aircraft at its final position while disembarking the passengers

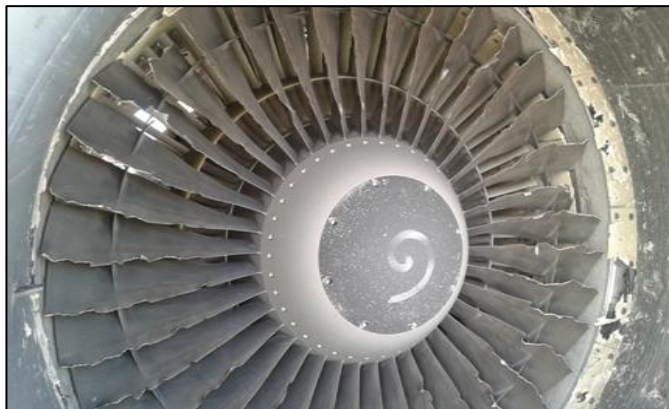
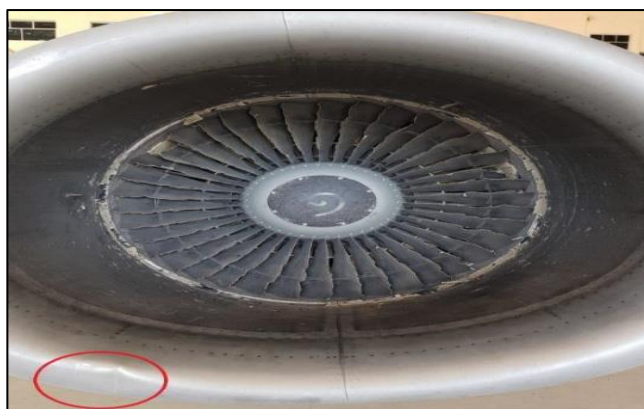
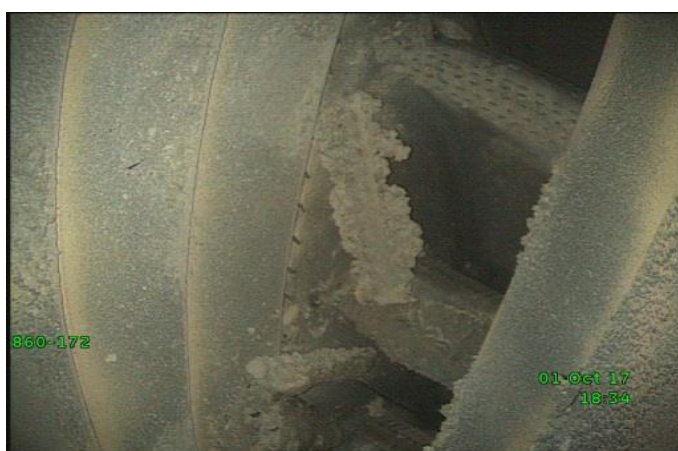
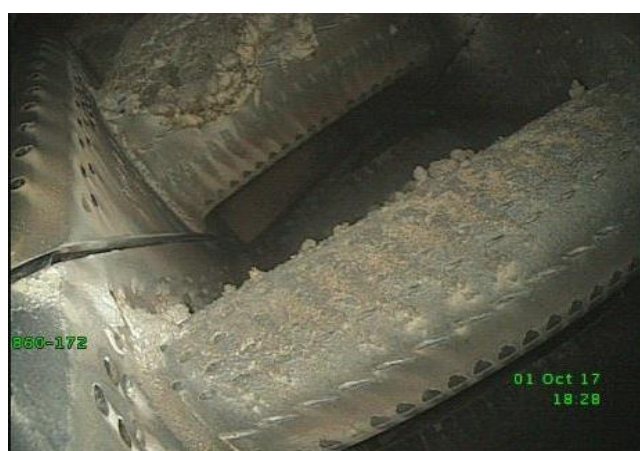
1. severe damage to No. 1 Engine S/No. 860172 due to the impact with approach lights the damage was observed in the following:
 - a) damage to the outer fan blades, as illustrated in [figure 1.3](#).
 - b) sever damage to the inlet nose cowling, as illustrated in [figure 1.4](#)
 - c) Borescope found out of limit findings at the majority of stages 1-9 along with massive solid sand build ups at HPT, Combustion Chamber, and Shroud and NGV.
 - d) Air inlet cowl, fan blades, thrust reverser and blocker doors and fan cowl found with impact and damage.
 - e) Solid sand buildup on both engines as illustrated in [figure 1.5](#) and [figure 1.6](#)
2. No severe damages were reported on Engine No. 2.

Nevertheless, solitaire air elected to drop both engine as the number of cycles available for Engine No. 2 was limited and both were sent to overhaul shop.

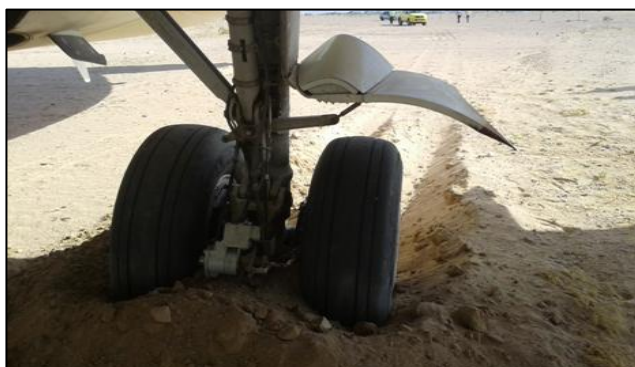
Figure 1.7

1. All MLG wheels and tires with damage. (tires at the incident scene illustrated in [figures 1.7](#) of the LH MLG and [figure 1.8](#) of RH MLG)
2. LH MLG damper apex joint pin slight out of position, as illustrated in [figure 1.9](#)

All landing gears were replaced after a one off flight exemption to AMM as the landing gears were due to replacement according to company CMP

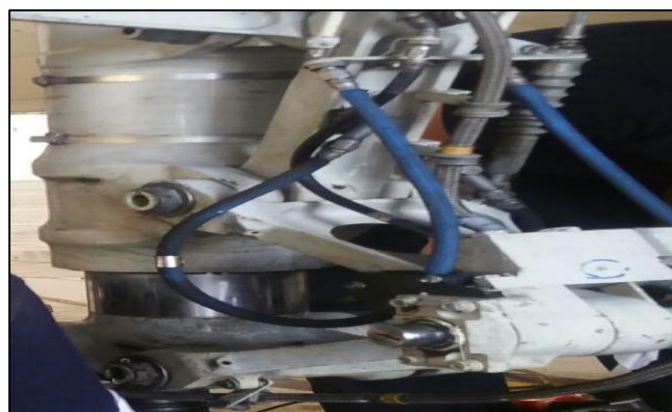
Figure 1.10

9. LH and RH MLG lower lateral axle areas with scratches.
10. LH MLG damper apex joint pin out of position.
11. RH MLG damper/ upper torsion link with body leaking and dent as illustrated in [figure 1.10](#)

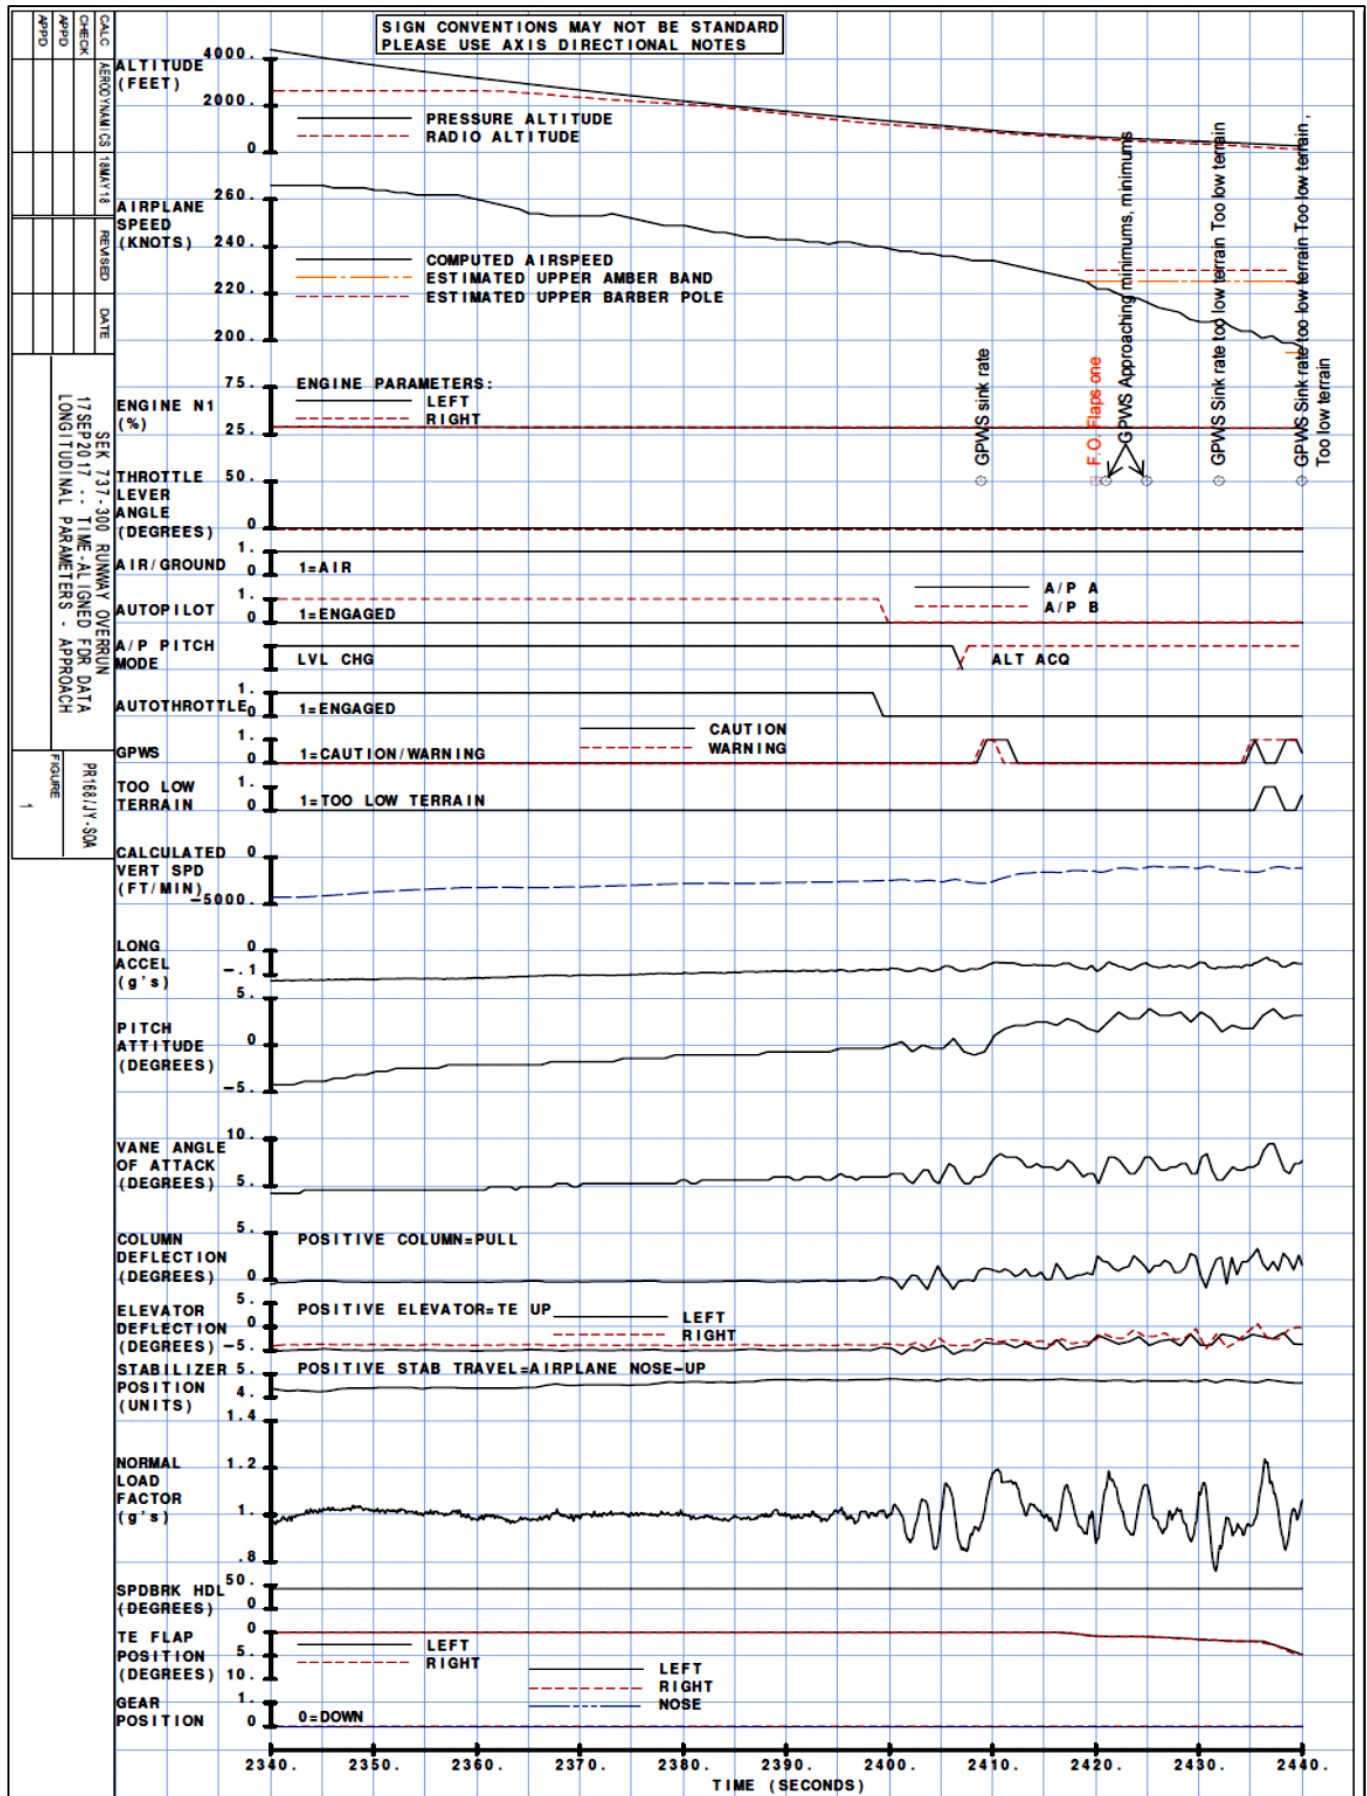
Figure 1.15

The computed airspeed was steadily decreasing, and at time 2399 seconds the autopilot and autothrottle disconnected as the airplane descended through 1215 feet radio altitude ([Figure 1.15](#)). The cause of the autopilot and autothrottle disconnects could not be definitively determined from the available data. Following autopilot disengagement there was a notable increase in the magnitude of control column fluctuations, resulting in normal load factor variations of +/- 0.2 g's. At time 2407 seconds the flight mode annunciator (FMA) pitch mode transitioned from LVL CHG to altitude acquire (ALT ACQ).

The data indicate the occurrence of a Ground Proximity Warning System (GPWS) activation at time 2409 seconds ([Figure 1.15](#)). Note that the FDR combines multiple alerts into general warning and caution discretes, and does not record all of the individual alerts. The flaps began to extend to flaps 1 at time 2417 seconds (650 feet radio altitude), and from flaps 1 to flaps 2 shortly afterward at time 2425 seconds (460 feet radio altitude). Only the trailing edge flap deflections were recorded on the FDR, the flap handle position was not recorded.

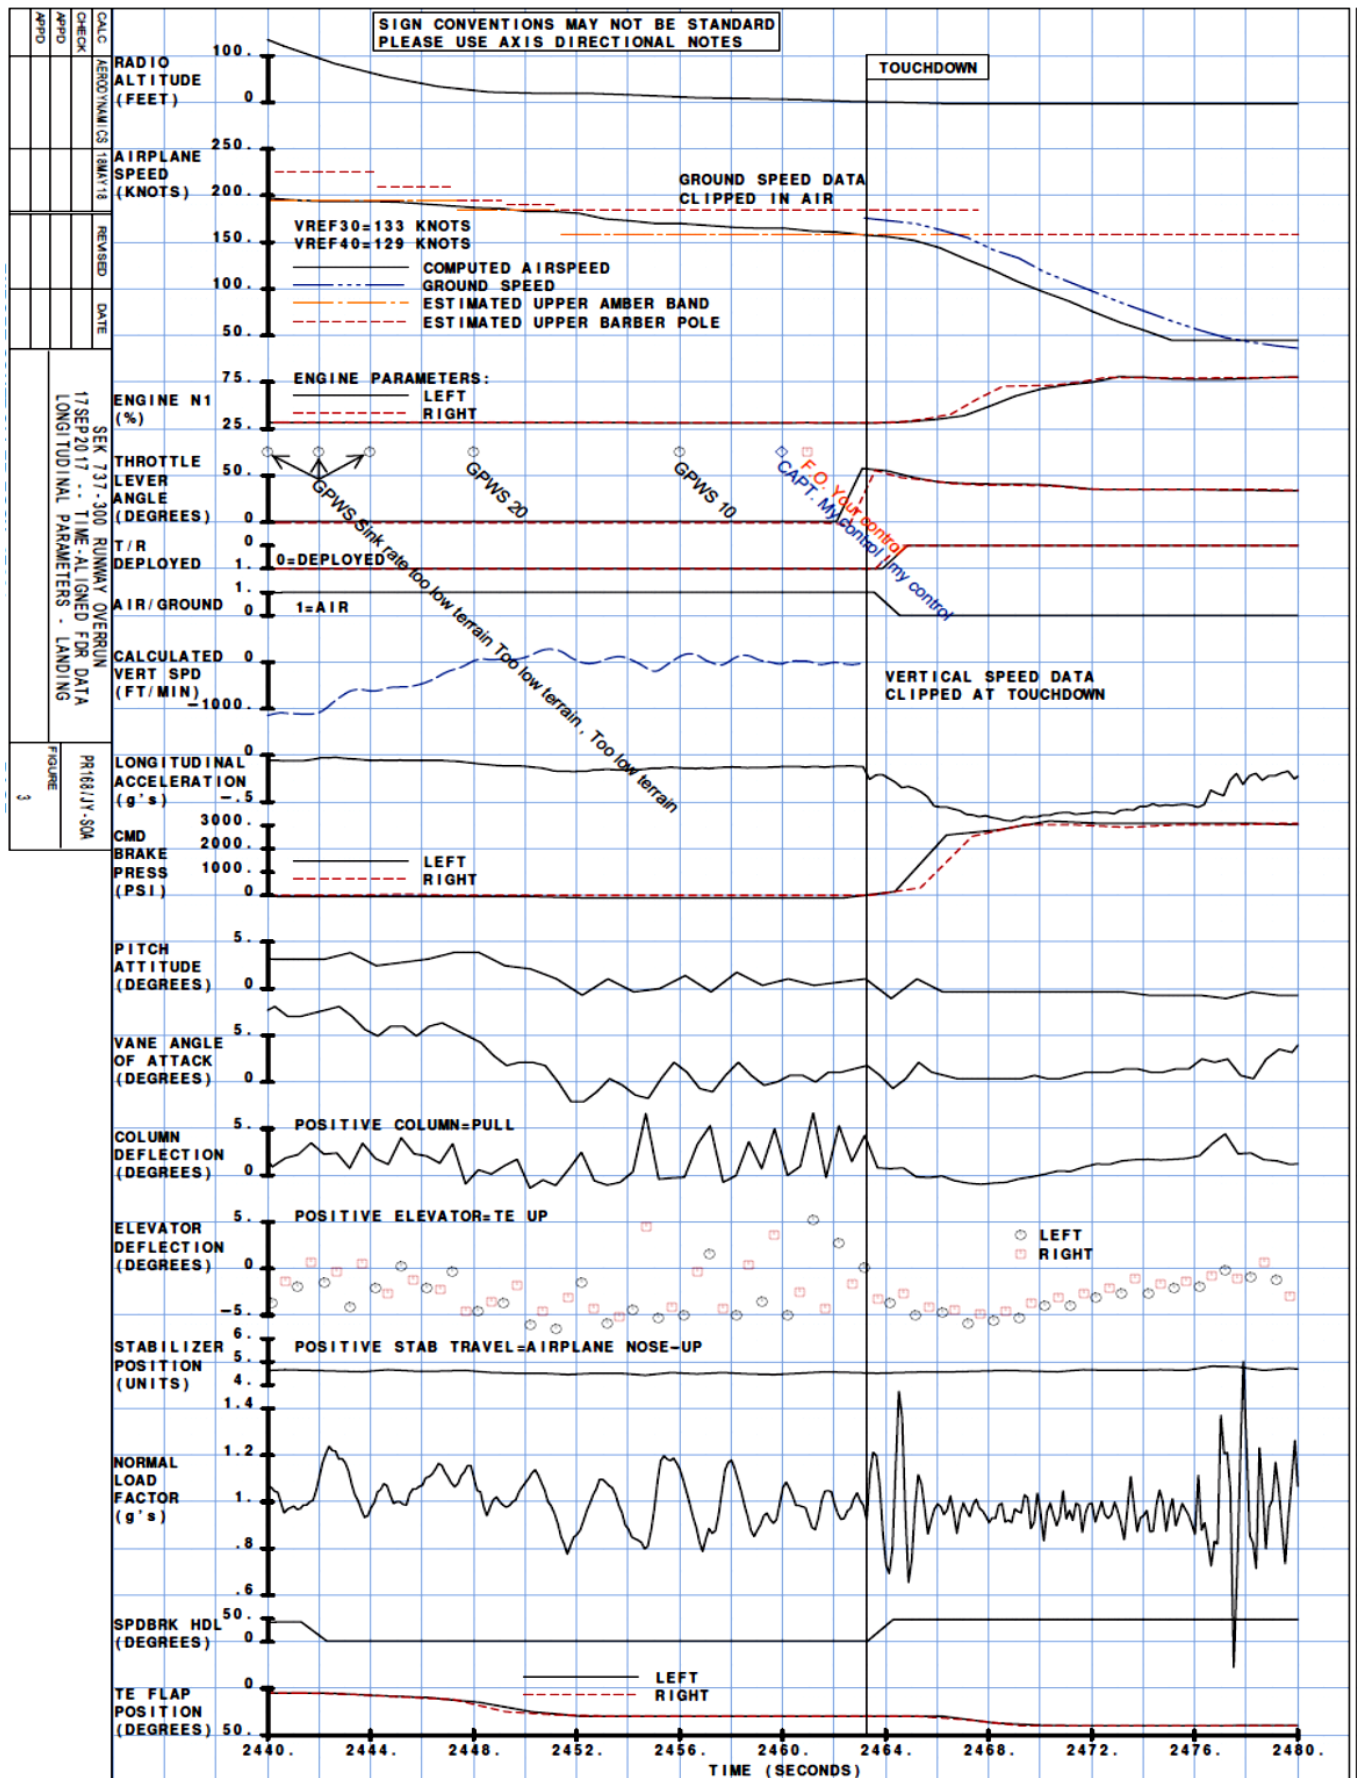
Figure 1.17

At time 2442 seconds (90 feet radio altitude) the flaps began to extend from flaps 5 towards flaps 30 ([Figure 1.17](#)). The speedbrake handle was also retracted at this time. As the flaps extended, the calculated sink rate began to decrease, until stabilizing at approximately 0 fpm at time 2448 seconds (25 feet radio altitude). The airplane then proceeded to float down the runway, with the radio altitude and computed airspeed gradually decreasing. The airplane descended through 20 feet radio altitude at time 2450 seconds. The flaps remained in transition until they arrived at flaps 30 at time 2452 seconds, by which time the pitch attitude had decreased to approximately 0 degrees. Beginning at time 2454 seconds (16 feet radio altitude), numerous momentary airplane nose-up control column inputs were recorded.

The airplane touched down at time 2463 seconds, as evidenced by a decrease in longitudinal acceleration, in combination with the transition of the AIR/GROUND discrete to GROUND([Figure 1.17](#)). The landing reference speed (VREF) was not recorded; however, at flaps 30 and a weight of approximately 108,000 pounds (not shown), VREF would have been approximately 133 knots. Touchdown occurred at a computed airspeed of 158 knots(VREF+25), at a groundspeed of 176 knots, and with a maximum normal load factor of 1.5g's. Note that the airplane did not exceed the flap placard speed (identified by the upper barber pole), the landing gear operation speed, or the landing gear extended speed at any point during the approach (Figures [1.15](#) and [1.17](#)).

Promptly after touchdown the thrust reversers deployed, the speedbrake handle extended, and brake pressure was applied ([Figure 1.17](#)). At time 2466 seconds, 3 seconds after touchdown, the flaps began to extend from flaps 30 to flaps 40. The commanded brake pressures had increased to the maximum of 3000 pounds per square inch (PSI) by time 2469 seconds, and by time 2473 seconds the engine N1s had stabilized at 80%, which is approximately equivalent to detent 2 reverse thrust. The airplane likely departed the paved surface around time 2477 seconds at a groundspeed of 50 knots, as evidenced by an increase in the perturbations in normal load factor, and a decrease in magnitude of longitudinal acceleration. Right control wheel and right pedal were also commanded at this time ([Figure 1.18](#)). The thrust reversers were stowed at time 2484 seconds at 25 knots ground speed, and the airplane came to a rest at time 2491 seconds (not plotted).

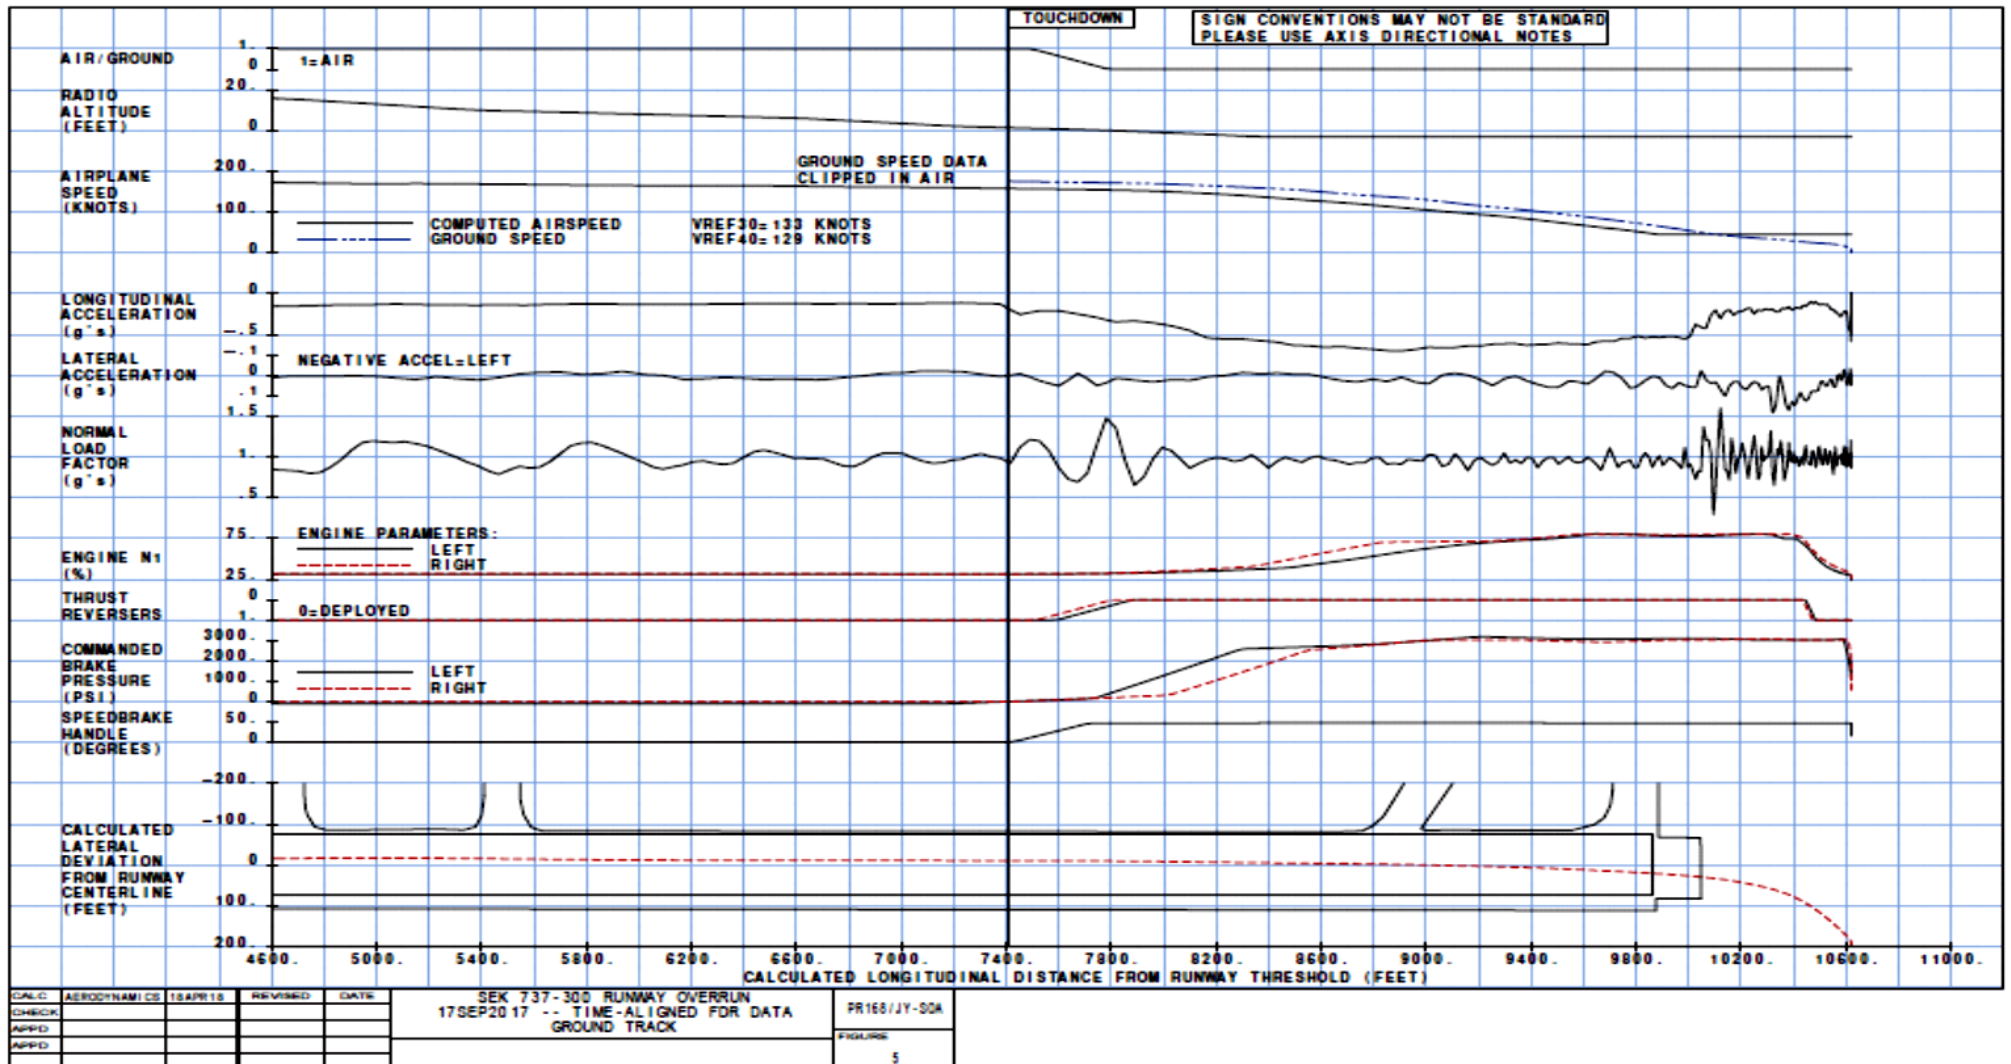
Figure 1.19

The ground track analysis results indicate the airplane crossed the threshold at approximately 115 feet radio altitude and with a computed airspeed of around 195 knots (VREF+62) [not plotted]. The airplane touched down around 7400 feet beyond the runway threshold (2650 feet prior to the end of the paved surface) [[Figure 1.19](#)]. The commanded brake pressures had reached the maximum of 3000 PSI around 1040 feet prior to the end of the paved surface, and the engine N1 stabilized at 80% around 490 feet prior to the end. As the airplane neared the end of the pavement, it began to deviate right of the centerline. The airplane came to a stop 10,600 feet beyond the runway threshold (600 feet beyond the end of the paved surface), and around 200 feet right of the extended runway centerline.
