Occurrence Investigation Report
Runway Excursion
Aircraft Overran the Runway during Landing
Solitaire Air
Boeing 737-300 JY-SOA
King Hussein Airport, Aqaba, Jordan
RYW 6888
AMM-AQJ
17September 2017

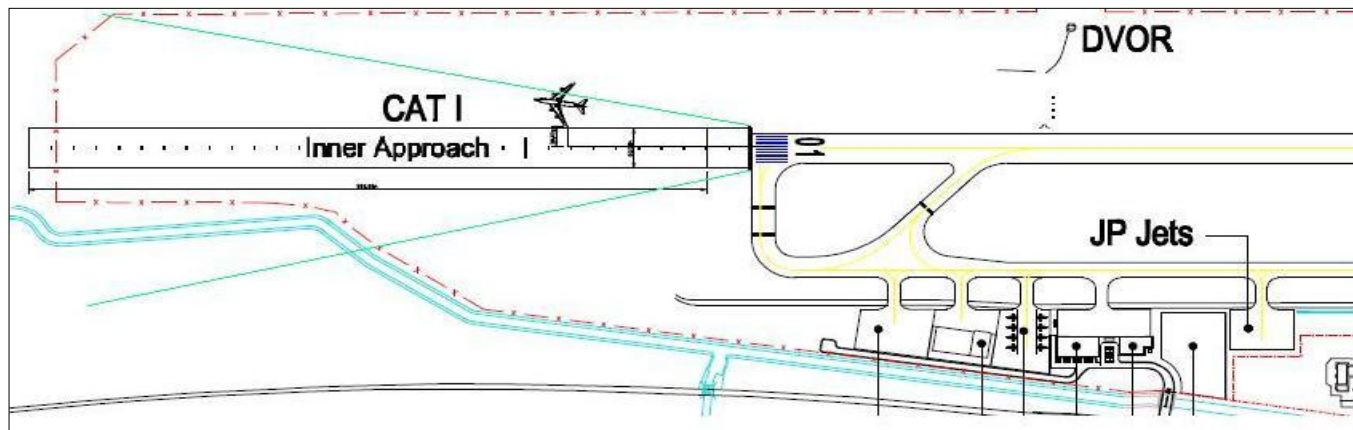
Figure 1.1

The aircraft has touchdown the runway at time 05:12:43 UTC around 7400 feet beyond RWY 19 threshold; (2650) feet prior to the end of the paved surface of RWY 0, and went off the runway few seconds after landing the aircraft stopped at 890 feet beyond the end of runway 01 threshold. [Figure 1.1](#) (represent the ground track of the aircraft along the runway and the final position)

The aircraft stopped approximately 600 feet in the unpaved area after RWY 01 threshold, the final position of the aircraft is illustrated in [Figure 1.1](#). Previously introduce in [subsection 1.1](#).

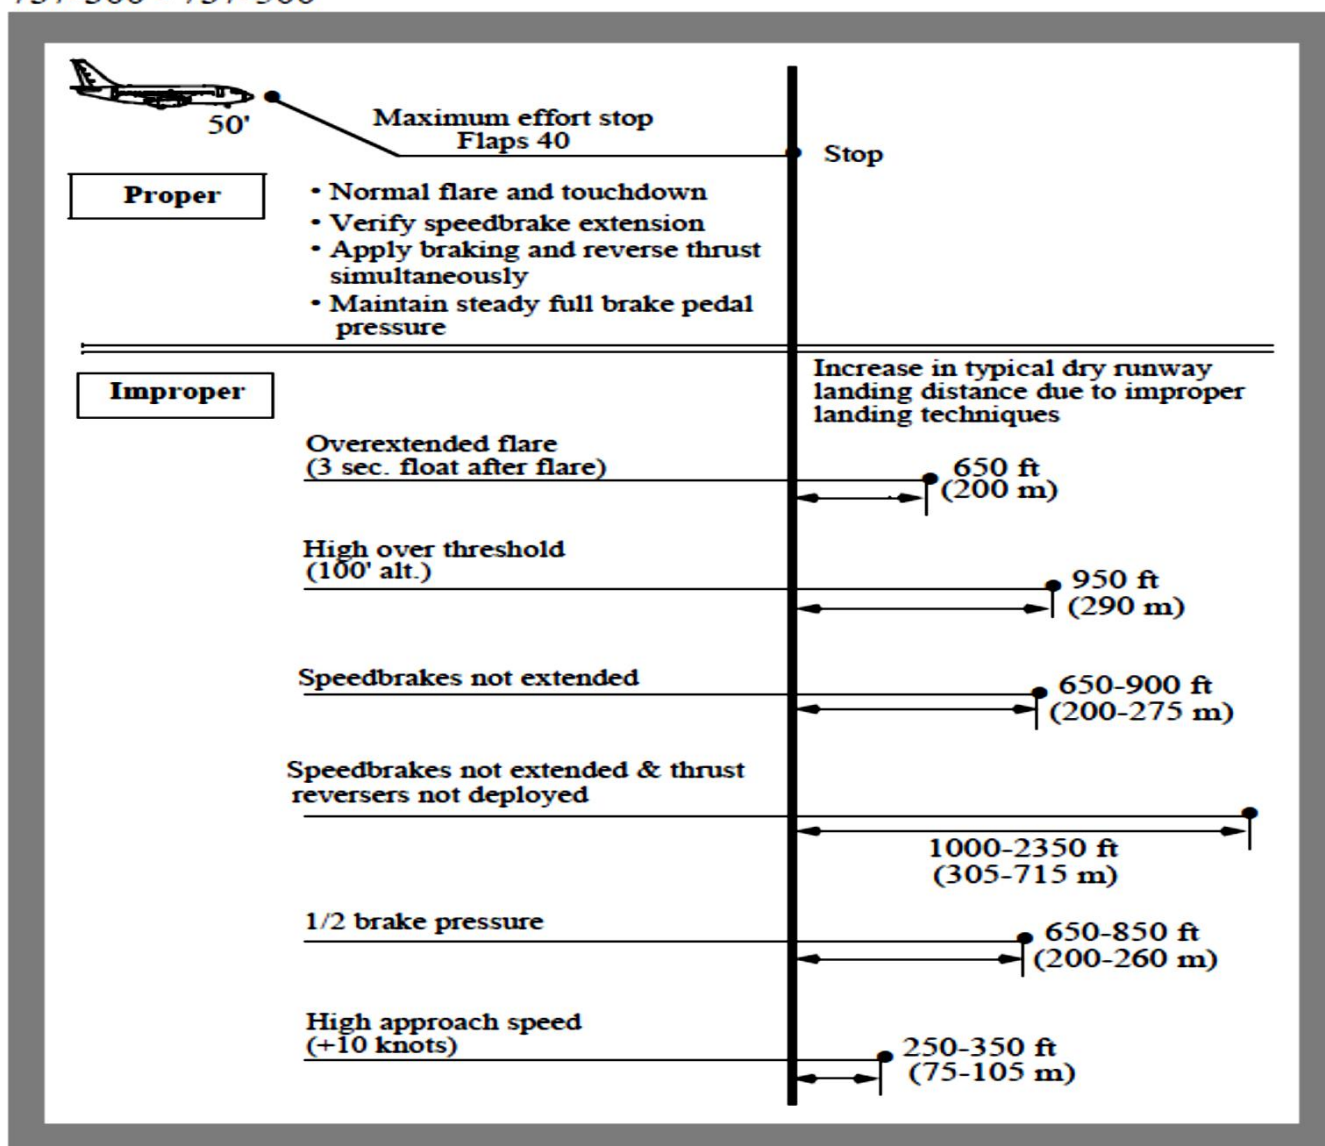
Figure 1.11

[Figure 1.11](#) shows typical increase in landing distance due to improper landing techniques compared to the proper (baseline) condition. These data are based on dry runway, sea level, standard day conditions with landing weights up to the maximum landing weight. Data exclude wet or contamination effects. When increased landing distance is shown as a range, it reflects variations in airplane weight and model variants (if applicable). These calculations are intended for training discussion purposes only.

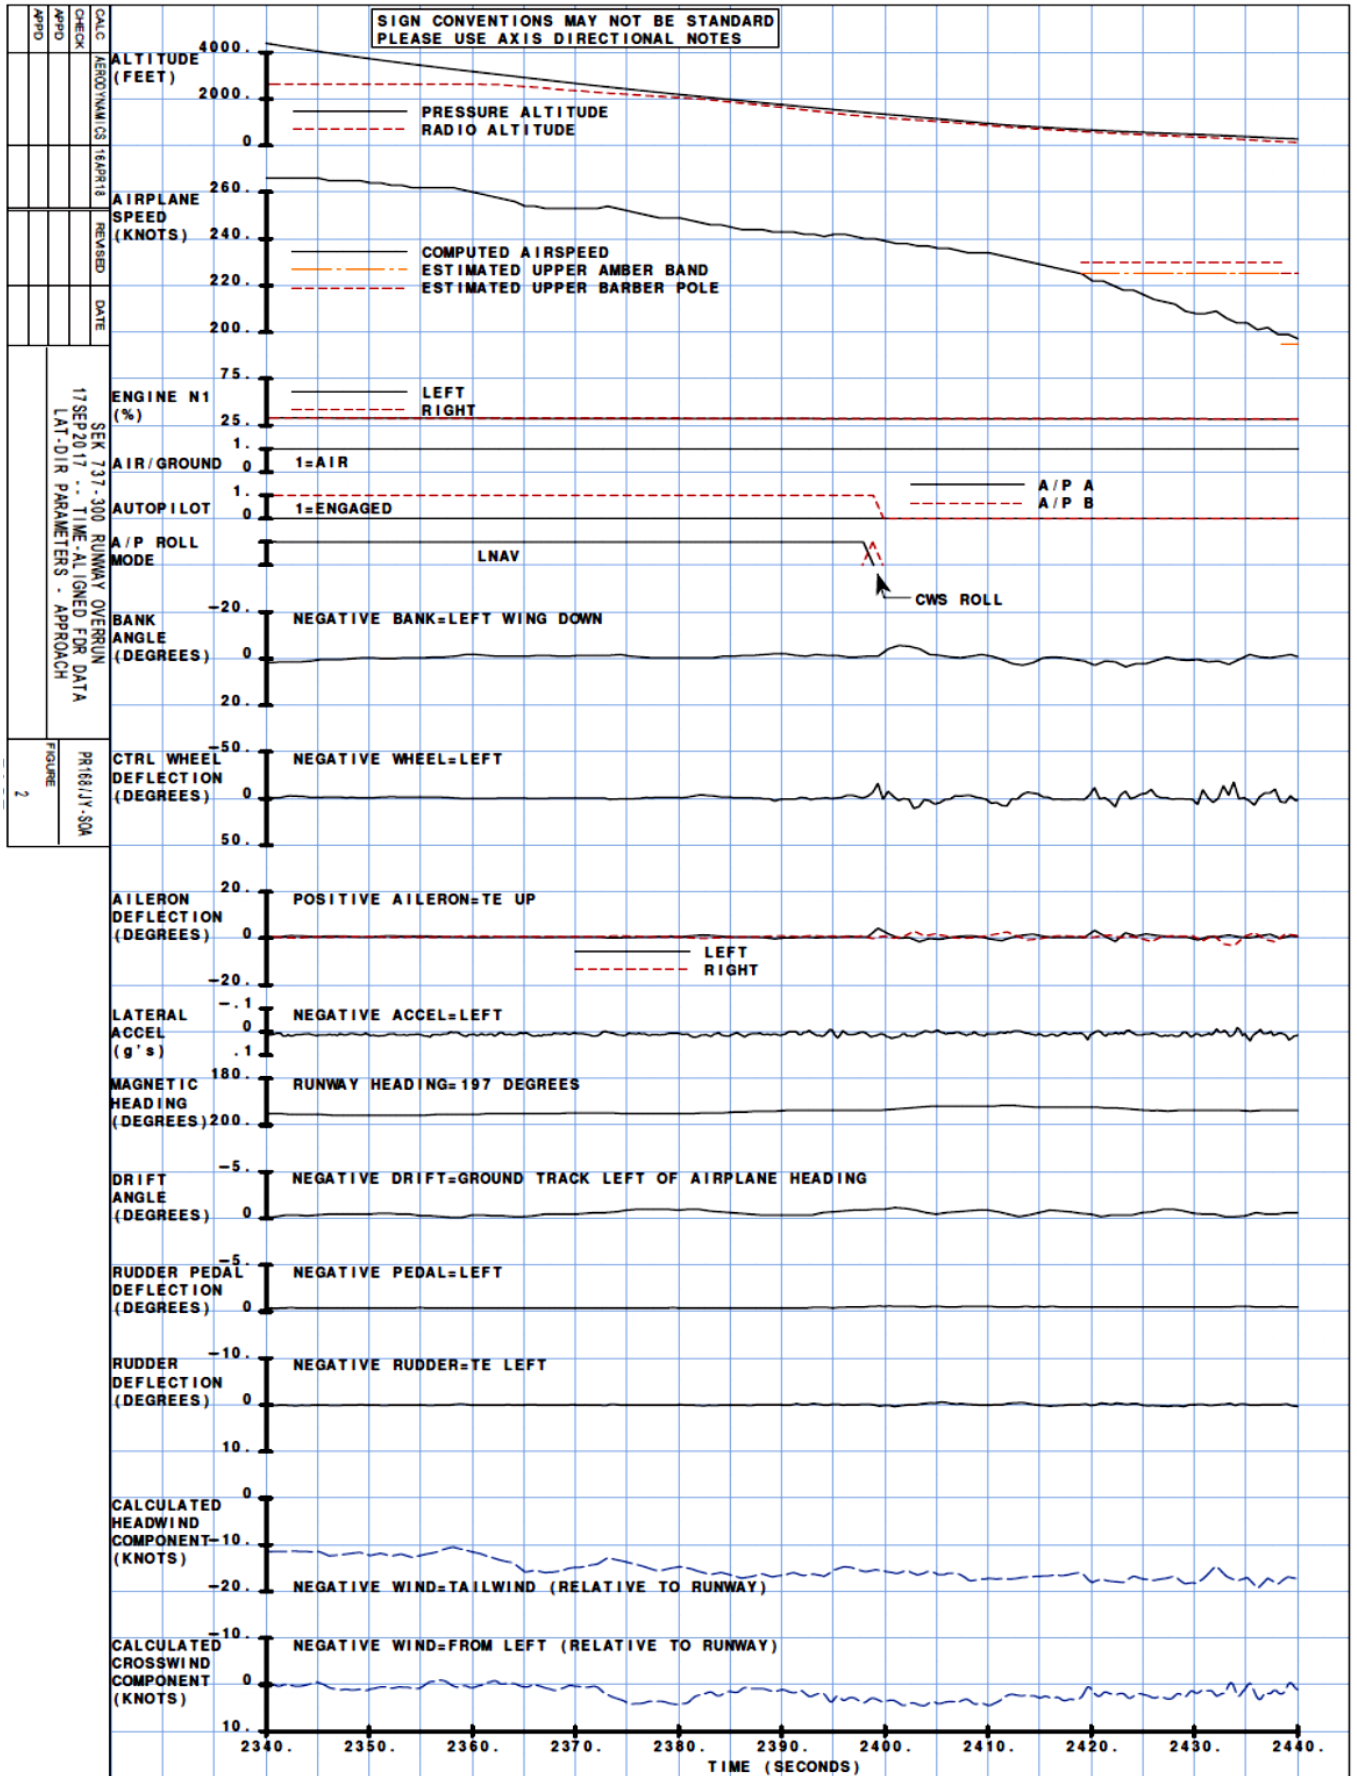
Figure 1.16

The airplane was descending through 4350 feet pressure altitude on approach to Runway 19 (verified by latitude/longitude data [not shown] and magnetic heading) at Aqaba. The airplane was at a computed airspeed of 266 knots, and the calculated sink rate (negative vertical speed) was approximately 4240 feet per minute (fpm) ([Figure 1.15](#)). The calculated wind components indicate a tailwind of around 12 knots relative to the runway and a negligible

crosswind ([Figure 1.16](#)). The calculated winds were consistent with those recorded on the FDR. Around time 2362 seconds the tailwind increased to approximately 16 knots, where it remained fairly steady until touchdown.

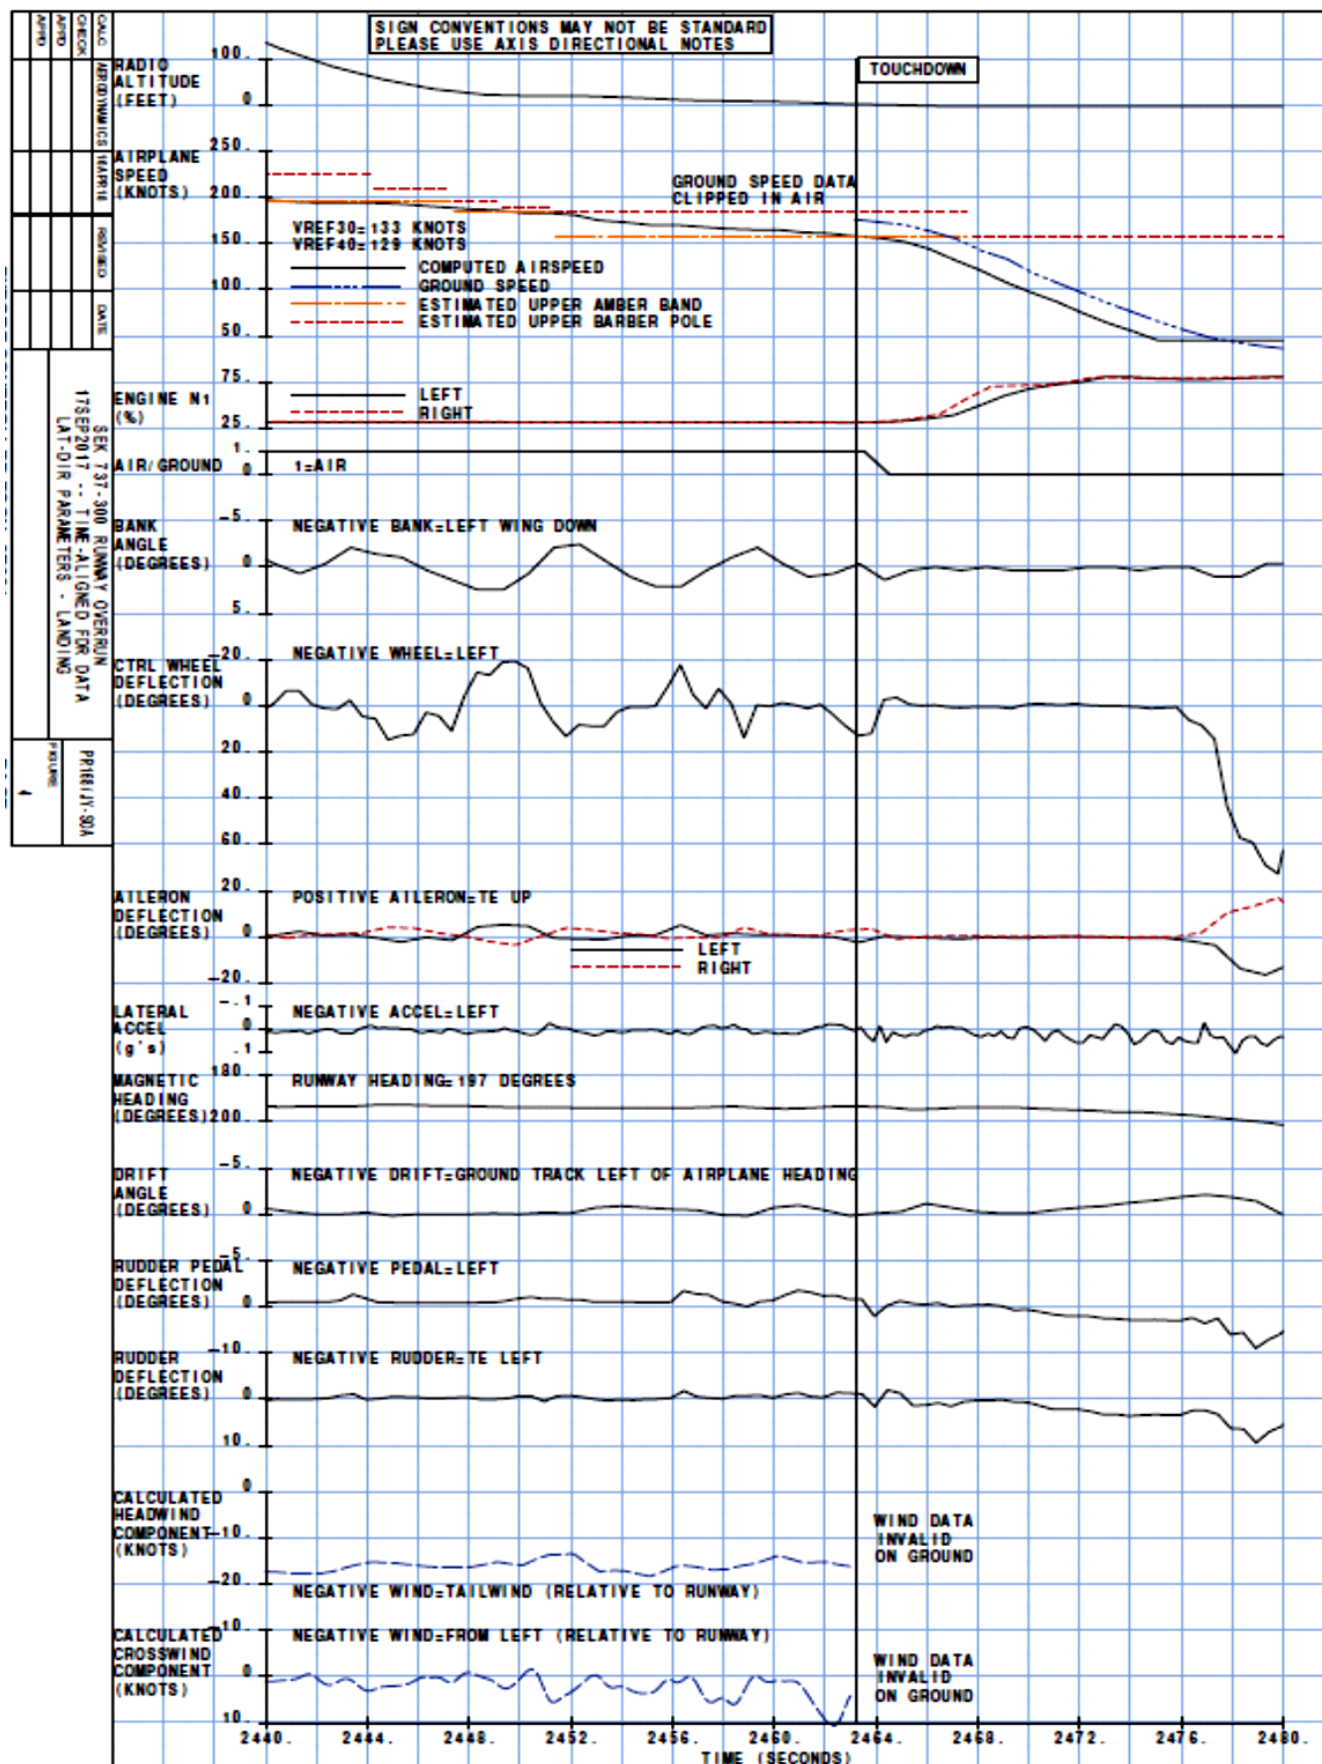
Figure 1.18

Time history plots of the pertinent longitudinal and lateral-directional parameters are attached as Figures 1.15 through 1.18. [Figures 1.15](#) and [1.16](#) focus on the approach, and Figures 1.17 and 1.18 focus on the touchdown and rollout. In addition to an evaluation of the FDR recorded parameters provided to Boeing, a kinematic analysis was conducted on the provided FDR data, to correct inherent inconsistencies often present in recorded data. Such inconsistencies may be due to sample rate differences, multiple independent data sources, and the presence of instrumentation biases. The kinematic analysis utilized integrated acceleration data to ensure basic inertial parameters such as altitude, ground speed, and drift angle are compatible and comparable. The analysis' output is a kinematically consistent set of data with acceleration biases removed, allowing calculations of wind data and other parameters information.
